Fatigue degradation and electric recovery in Silicon solar cells embedded in photovoltaic modules

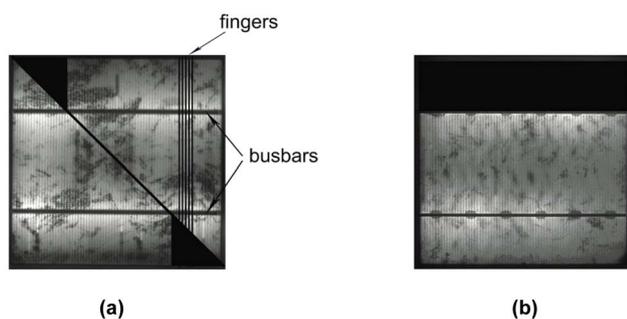
Figure 1 | Geometrical criterion showing the expected amount of potentially inactive cell areas depending on the orientation of the crack with respect to the busbars^{3,8}: 6% of potentially inactive cell (a); 25% of potentially inactive cell (b).

Cracks on the millimetre or centimetre size are mostly invisible by naked eye but they can be localized according to the EL technique¹³. Such cracks can lead to electrically inactive cell areas thus reducing the power output of the module and the fill factor¹⁴. This takes place via the following mechanisms, i.e.: a linear decreasing of the short circuit current by increasing the inactive cell area^{3,15,16}, and an increase in the series resistance of the cell due to cracking^{3,5}. For instance, experimental results⁵ have shown an increase in the series resistance of the cell of about 7% due to cracking with a corresponding power-loss of 4% and a fill factor reduction of 3%. Other experimental investigations³ have shown that cracks inserted in solar cells by the application of a uniform pressure to simulate snow can lead up to 1.5% of power loss. After the subsequent application of 200 humidity freeze cycles according to standard specifications¹⁷, such cracks propagate, the electrically disconnected areas increase in size and up to 10% of power loss has been reported. Potentially, if a crack crossing an Aluminium conductor (called finger) is sufficiently open, then the finger may fail and the electric flow to the busbar in case of normal operating condition, or from the busbar in case of forward bias condition as in the EL testing, would be interrupted. Therefore, portions of Si cells can be potentially deactivated by cracks and their impact on power-loss reasonably depends on their inclination and position with respect to the busbars, see Figs. 1(a) and (b). For instance, a crack parallel to the busbar on the upper side of the cell could lead up to 25% of electrically inactive area (Fig. 1(b)). According to this pure geometrical criterion which does not take into account neither physical

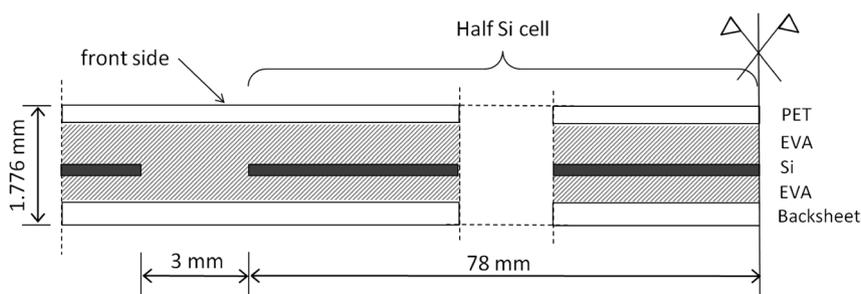
Figure 2 | Sketch of the cross-section of the PV module near the symmetry line.

To make an insight into the mechanisms leading to these coupling effects, a bending test on a rectangular PV module has been performed in the laboratory by monitoring cracking at different deformation levels by EL imaging. A semi-flexible module made of 2 rows of 5 monocrystalline Si cells each is used. The dimension of the cells is 156×156 mm. The partially symmetric arrangement of the layers through the thickness (0.265 mm of polyethylene terephthalate, 0.600 mm of epoxy-vinyl-acetate, 0.166 mm of Silicon, 0.400 mm of epoxy-vinyl-acetate and 0.345 mm of backsheet) and the different Young moduli of the materials lead to Si cells just above the neutral axis of the cross-section (see Fig. 2). This type of module, which has a certain degree of flexibility, can be used in many applications where the substrate we would like to bond the module is curved. In order to induce a tensile stress state inside solar cells, the curvature imposed to the module is such that the convex side after bending corresponds to the PET side (front side in Fig. 2).

To assess the residual stress and deformation states inside the PV module, a 2D plain strain finite element (FE) model of the layered composite in the plane of bending has been analyzed using the Finite Element Analysis Programme FEAP²³. Taking advantage of the structural symmetry, one half of the module has been analyzed by introducing symmetry boundary conditions on the symmetry line. The opposite edge of the module is simply supported in the direction orthogonal to the longitudinal axis. The thermal expansion coefficients of the plastic layers, EVA and Silicon are, respectively, $\alpha = 5.04 \times 10^{-5}$, 2.70×10^{-4} and 2.49×10^{-6} . The other elastic parameters are as in Ref. 24. Due to its thermo-visco-elastic behaviour, a Young modulus of EVA equal to 1 MPa has been selected, which is the lowest value in the considered range of temperatures according to experimental results²⁴. In any case, a possible variation of the Young modulus of EVA from 1 to 10 MPa is inducing an increase of about 10% in the compressive stresses inside Silicon. The FE computations

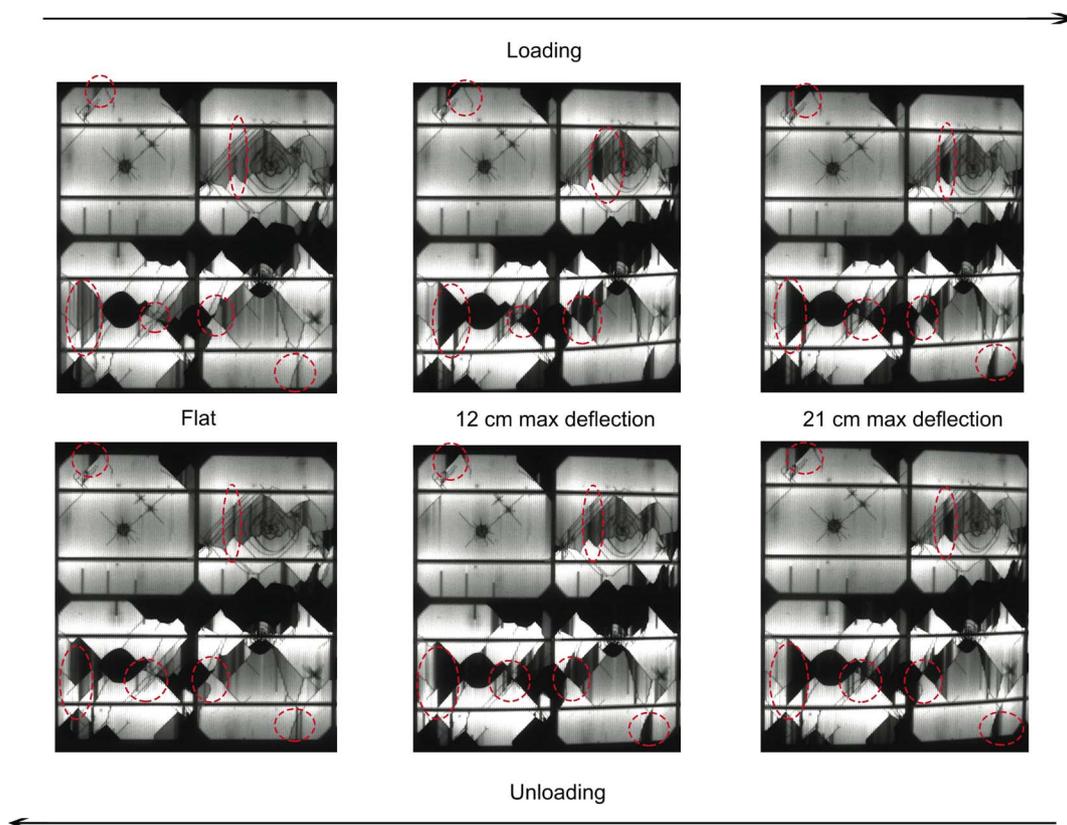
Figure 3 | Evolution of EL signal during bending loading and unloading for different deflections.

To create pre-existing cracks and study their evolution depending on the imposed flexure, moderate impacts have been made with PMMA balls of 4 cm of diameter at a velocity of 6 m/s. In this way, cracks are introduced by an indentation effect. The EL images of four solar cells in the middle of the panel are shown in Fig. 3.

Location of impacts can be clearly distinguished by the circular dark spots from where diagonal cracks, influenced by the crystallographic planes of cubic face centred monocrystalline Silicon, depart. These patterns are completely invisible by naked eye and can only be determined by the EL technique. In some cases, large electrically insulated cell portions, appearing as dark areas, are present. Other portions, circled with dashed lines, show regions isolated by cracks but still partially conducting from the electrical point of view. This can be well explained by the assumption that their crack opening is smaller than a critical value for complete electric insulation and by a compressive stress state inside the cells due to residual thermo-elastic stresses induced by cooling down the module from the lamination temperature at 150°C to the ambient temperature at 20°C .

By increasing the mid-span bending deflection (upper row in Fig. 3, loading direction from left to right), cracks open and additional insulated dark areas appear, thus confirming that the electrical behaviour of cracks does depend on the elastic deformation. Very interesting is the unloading stage (lower row in Fig. 3, unloading direction from right to left), where cracks come into contact and conduct again. Hence, although globally the amount of damage is increased during the cycle since the final EL image is more dark than before, an electric recovery due to crack closure is reported.

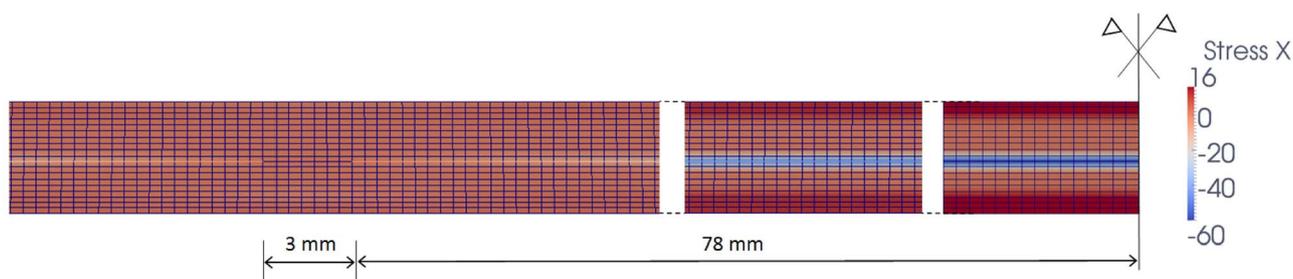
Figure 4 | Contour plot of the horizontal stresses inside the PV laminate in the portion near the symmetry line.

estimate a compressive stress field in the Si cells variable from 0 MPa at their borders up to 60 MPa in their centre (see the contour plot in Fig. 4). Therefore, this residual stress field is beneficial for the module since any initial crack or defect present in Silicon would be closed by compression.

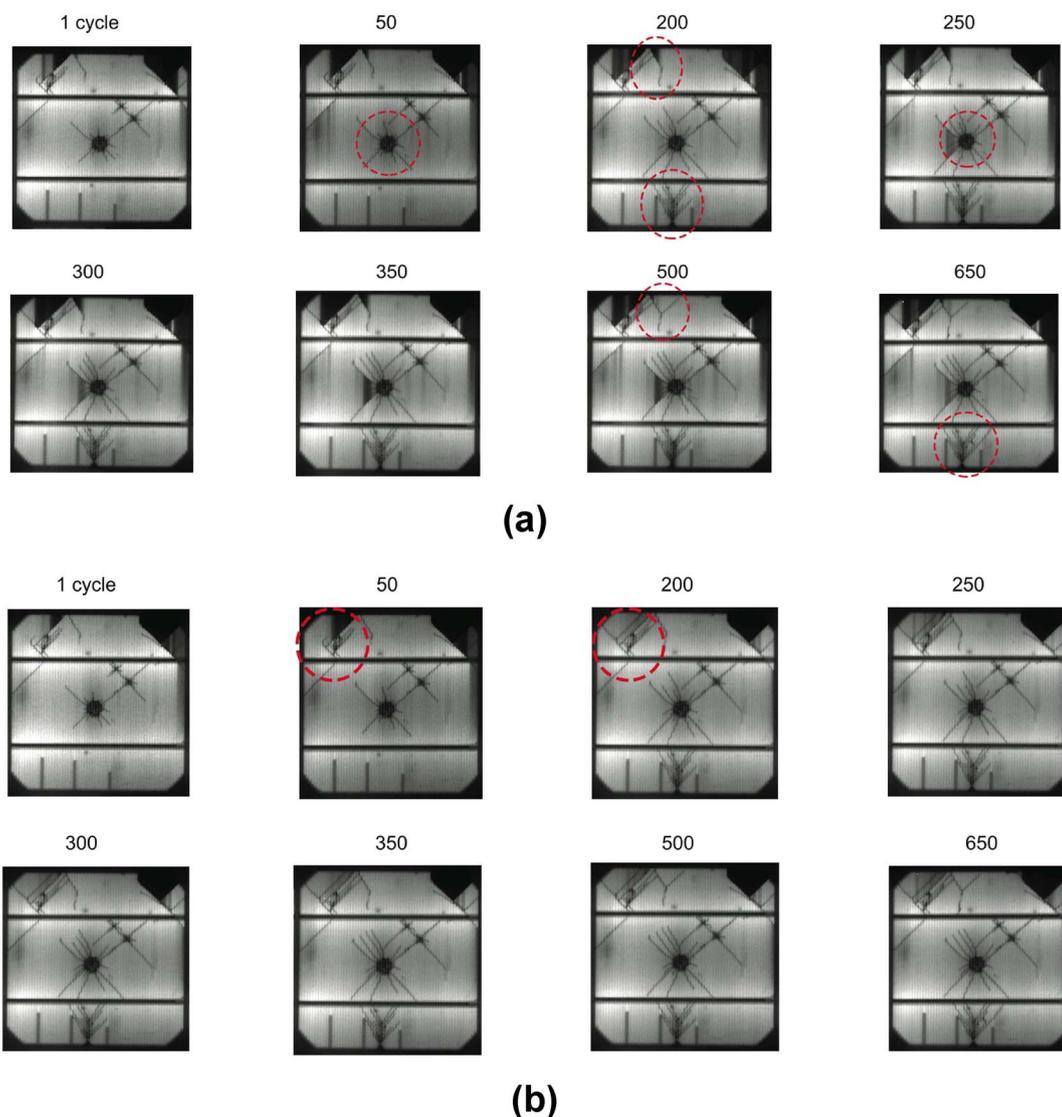
Figure 5 | Fatigue degradation of the electric response and increasing crack pattern at different bending cycles. EL images are taken at the maximum deflection point of the module ($\delta = 21$ cm) (a) and at the unloaded configuration ($\delta = 0$ cm) (b).

The evolution of degradation by increasing the amount of bending cycles (from zero to a maximum mid-span deflection of 21 cm per cycle) has also been monitored and it is shown in Fig. 5(a), where EL images of a significant cell of the module have been recorded at the point of maximum deflection for 1, 50, 200, 250, 300, 350, 500 and 650 cycles. The cyclic tests have been conducted in the ambient temperature (20°C). Regarding the EL measurement procedure, to

During the first 50 cycles we report a propagation of cracks around the dark central point of impact. Crack propagation further takes place from 50 to 200 cycles, with the appearance of new cracks from the lower border of the cell, originating from an edge crack. No crack

propagation takes place from 200 to 250 cycles, although the EL intensity between diagonal cracks diminishes, thus implying a material degradation and a reduction of electric conductivity across the cracks. This trend continues further by increasing the number of cycles, with also further crack propagation (cycle 300) and coalescence of two propagating cracks (cycle 350). At 500 cycles, a new crack is originated from an initial one on the upper side of the cell as a result of a crack-branching mechanism. After the appearance of this new crack, the dark EL area just on the left of it becomes conductive again. This can be explained as the effect of the phenomenon of strain localization, frequently observed in brittle materials, which corresponds to a stress relief in the surrounding cracks when a major crack propagates¹⁸. Therefore, with the appearance of a new crack, the previous one in the surrounding is relaxed and it experiences a reduction of its relative opening displacement.

Finally, strain-localization can be evidenced again by comparing in Fig. 5(b) EL images for 50 and 200 cycles, see the circled areas. The propagation of a diagonal crack to the left relieves the deformation in the Si area, the diagonal crack on the right experiences a reduction in crack opening and the EL image of Silicon above becomes brighter.

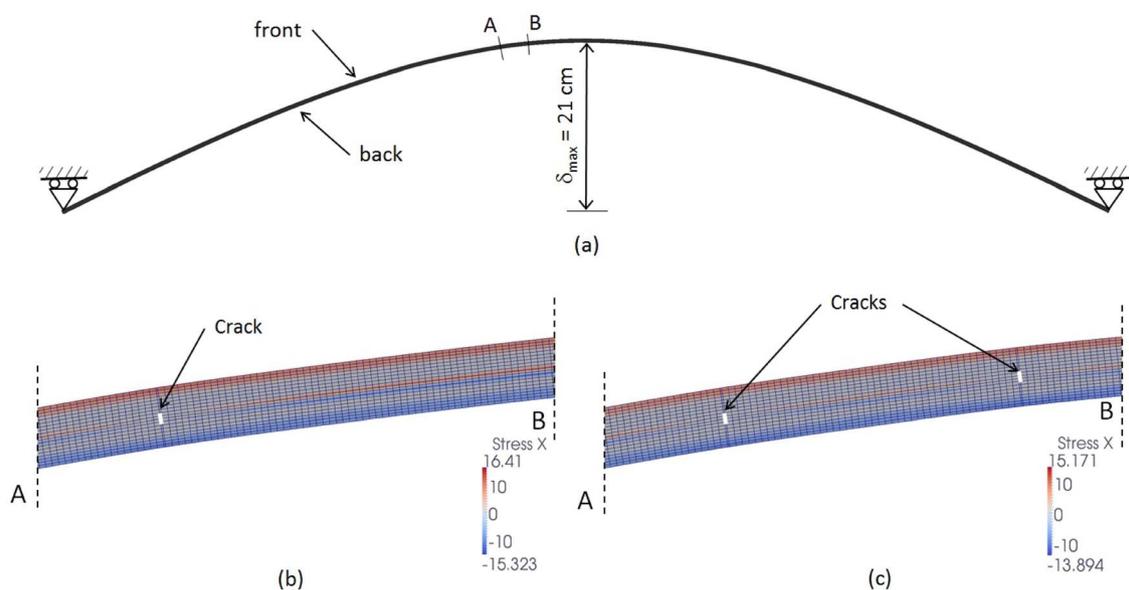
Figure 6 | Structural scheme (a); contour plot of the horizontal stress field in case of one single crack (b); contour plot of the horizontal stress field in case of two cracks (c).

To confirm the effect of a new crack on the crack opening of a pre-existing crack in case of a brittle material embedded in the laminate, a FE study based on nonlinear fracture mechanics is proposed. For more details about the CZM, see Ref. 9. In the 2D approximation of the PV module shown in Fig. 6(a), one or two cohesive cracks (distant 0.9 cm from each other) are introduced in the Si cell placed near the symmetry line (see Figs. 6(b) and 6(c)). In the numerical simulations, the PV module is loaded by imposing a displacement to

the middle cross-section up to $\delta_{\max} = 21$ cm as shown in Fig. 6(a). Residual thermo-elastic stresses are not considered here for the sake of simplicity. If the stress relief takes place, then it would happen also in the presence of residual thermo-elastic stresses. A very low cohesive peak stress of $\sigma_{\max} = 0.2$ MPa is considered to simulate a very low cohesion due to a severe state of damage. The contour plots of the horizontal stress field superimposed to the deformed meshes of the portion of the module where cracks are placed are shown in Figs. 6(b) and 6(c). Stresses are slightly reduced by the simultaneous presence of two cracks and the crack opening of the pre-existing crack reduces from 11 μm to 9 μm . Therefore, the effect of strain localization induced by the propagation of new cracks supports the hypothesis of unloading effects at pre-existing cracks that might come into contact, thus leading to a recovery of their electric conductivity.

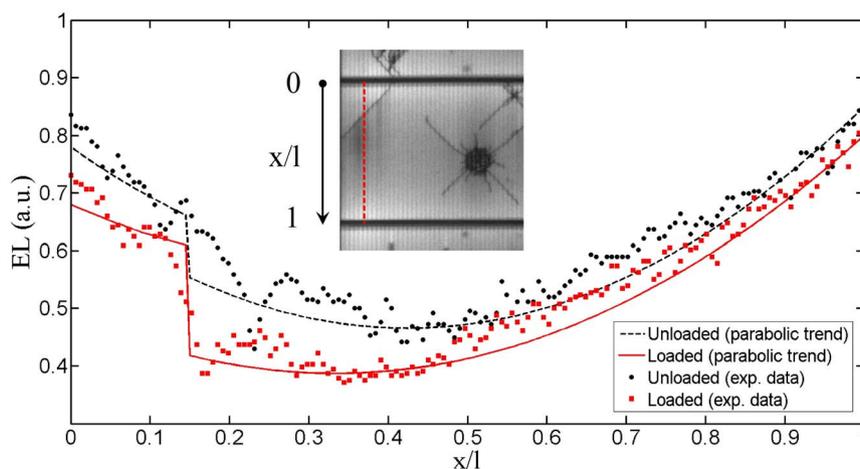
Figure 7 | EL data along a cross-section passing through a crack for 50 cycles in the loaded and unloaded configurations.

The phenomenon of electric recovery due to crack closure already noticed in the case of the first cycle can be observed also after several cycles. For instance, comparing the EL data along a cross-section perpendicular to the busbars and passing through a crack in the loaded and unloaded configurations for 50 cycles (Figs. 5(a) and (b)), we obtain the diagram in Fig. 7. Values of EL close to unity correspond to very bright Si areas, whereas values close to zero are dark “electrically inactive” zones. As visually emphasized by the superimposed parabolic trend with a discontinuity of first type in

correspondence of the crack ($x/l = 0.15$), a jump in the EL data takes place and it is higher for the configuration at maximum deflection where the crack opening is reasonably larger.

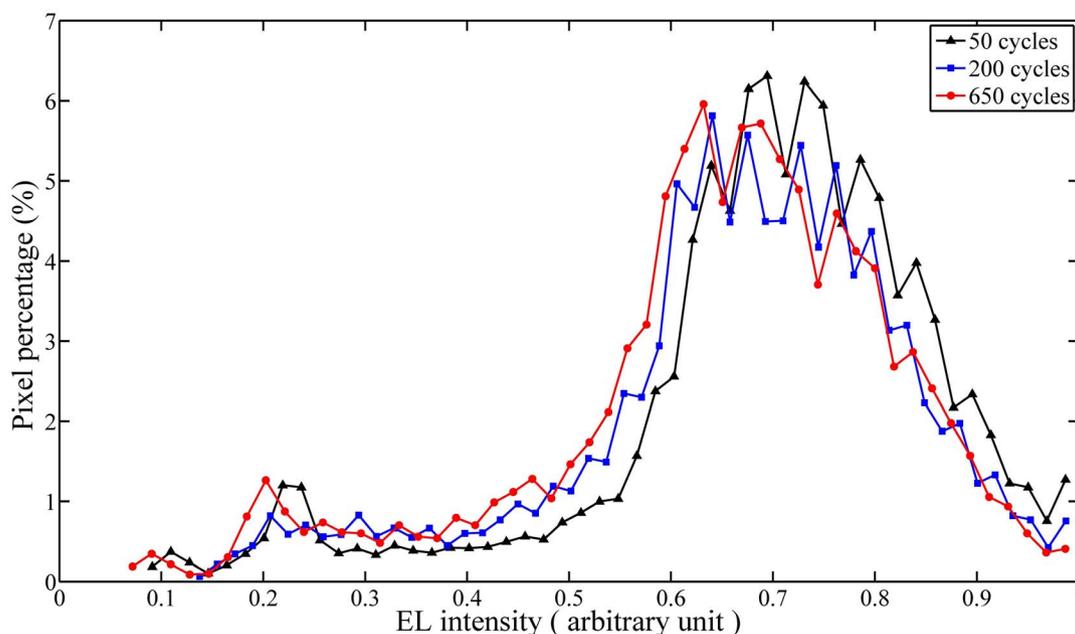
Figure 8 | EL distributions for different number of bending cycles at maximum deflection. Note the shift of the distributions to the left by increasing the number of cycles, a trend consistent with the progression of fatigue degradation.

A quantitative analysis of EL images at maximum deflection (Fig. 5(a)) shows that the statistical distribution of pixels having a given EL intensity is particularly skew-symmetric, with a long tail for EL intensities less than 0.5 (Fig. 8). Moreover, although the difference between EL images by increasing the number of cycles is apparently marginal, i.e., only a few cracks propagate and some regions become darker, the EL distributions quantify the fatigue degradation trend. By increasing the number of cycles, in fact, the EL distribution shifts to the left. For high EL intensities, the pixel percentage is diminished by increasing the number of cycles. Exactly the opposite trend takes place in the low EL intensity range, i.e., more pixels become darker.
