A Power and Energy Procedure in Operating Photovoltaic Systems to Quantify the Losses According to the Causes

Abstract: Recently, after high feed-in tariffs in Italy, retroactive cuts in the energy payments have generated economic concern about several grid-connected photovoltaic (PV) systems with poor performance. In this paper the proposed procedure suggests some rules for determining the sources of losses and thus minimizing poor performance in the energy production. The on-site field inspection, the identification of the irradiance sensors, as close as possible the PV system, and the assessment of energy production are three preliminary steps which do not require experimental tests. The fourth step is to test the arrays of PV modules on-site. The fifth step is to test only the PV strings or single modules belonging to arrays with poor performance (e.g., I - V mismatch). The sixth step is to use the thermo-graphic camera and the electroluminescence at the PV-module level. The seventh step is to monitor the DC racks of each inverter or the individual inverter, if equipped with only one Maximum Power Point Tracker (MPPT). Experimental results on real PV systems show the effective

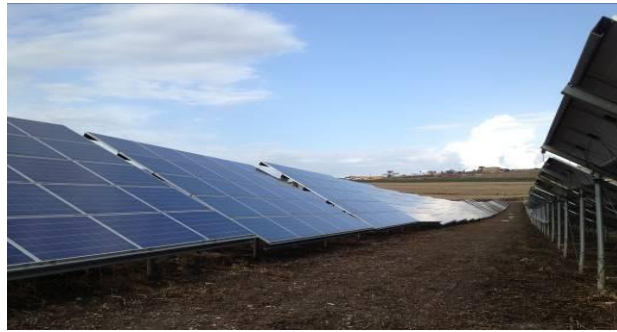
The *GMPV* system includes both PV modules in poly-crystalline silicon (p-Si), accounting for 3 MWp, and the remainder (0.3 MWp) in mono-crystalline silicon (m-Si). Fig. 1 shows two successive rows of PV modules mounted on open structures close to the terrain. They are arranged in PV arrays which supply MPPT racks with 55 kW rated power. Nine 330 kVA inverters with six MPPT racks each convert DC energy into AC energy delivered to the medium voltage grid.

Fig. 1. Photo of two successive rows of PV modules in the *GMPV* system.

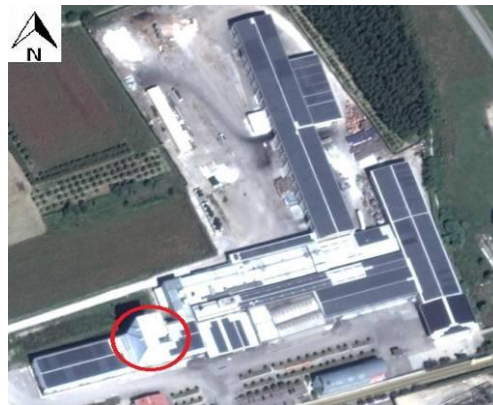
During the inspection of the *BIPV* plant, it was observed that a remarkable obstacle (Fig. 2 inside the red circle) can put into shade a part of the PV modules. The 3D model of the obstacle (a tower in the factory) in SketchUp with the near roofs, subject to lateral shades of tower, was created to estimate the resulting power losses on the PV modules. In details, the tower is 25-m higher than the roofs, where these PV modules are placed. The tilt of the roof is 6° , whereas the azimuths are -17° (southeastern) and $+163^\circ$ (northwestern). The decrease of productivity is different for each individual string and depends on the position in which it is installed. To carry out daily

Fig. 2. Satellite image of the 2.5 MWp *BIPV* system.

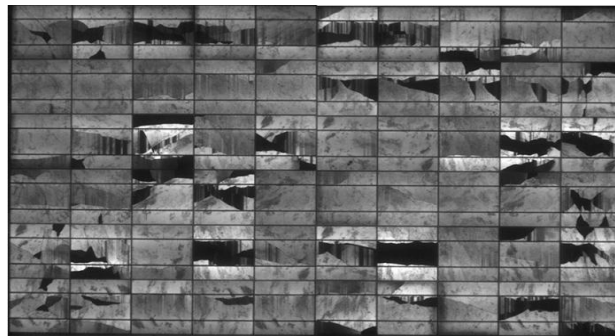
Regarding the same *BIPV* system, the high occurrence of cracks was noticed not only in m-Si modules, but also in p-Si modules (Fig. 16).

Fig. 16. EL image of a 60 p-Si cell module with high occurrence of cracks.
